ULTRASONIC INSPECTION OF CERAMICS CONTAINING SMALL FLAWS.(U)

MAR 77 T DERKACS, I M MATAY, W D BRENTNALL

TRW-ER-7867-F

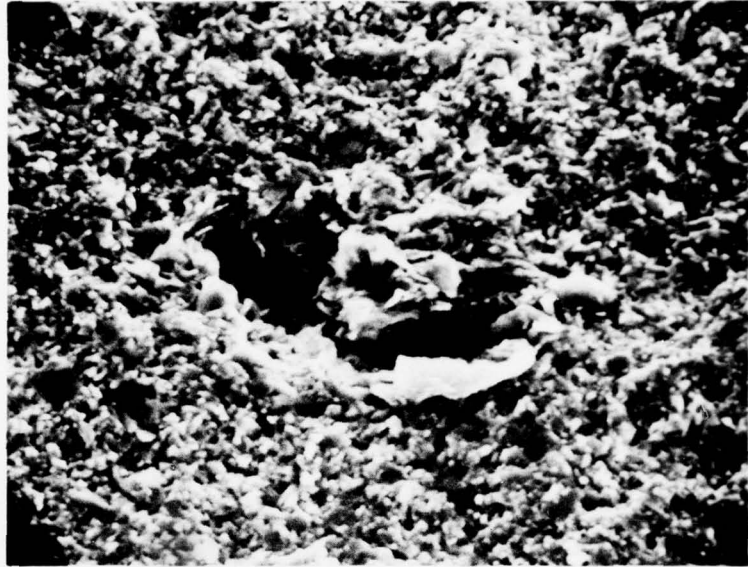
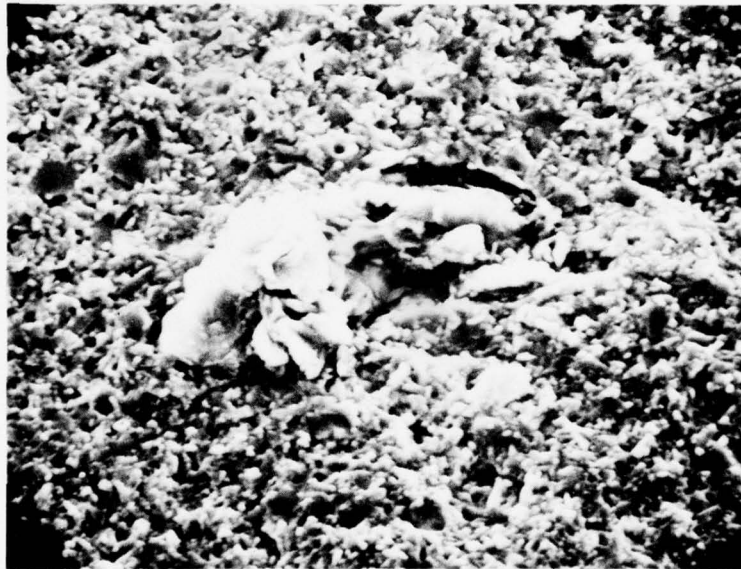
Figure 32. Fracture Initiation Site in Specimen 7 at High Magnification.

stayed in the other half. The defect is about $30 \times 70 \mu\text{m}$ and consists of several unidentified flake-like crystals. Figure 33 shows one side of the fracture origin in specimen 10, which is located 0.4 mm off center and $10 \mu\text{m}$ below the tensile surface. At 2000X it is seen to be an area of large crystals about $20 \times 40 \mu\text{m}$. Figure 34 shows one side of specimen 13. The mirror indicates the fracture origin is at or near the surface rather than at the defect that is present at a location that correlates well with the ultrasonic indication. The other side of the specimen shattered, so that the defect may have been lost as a result. It is therefore not clear whether or not this specimen failed as a result of the ultrasonically detected defect.

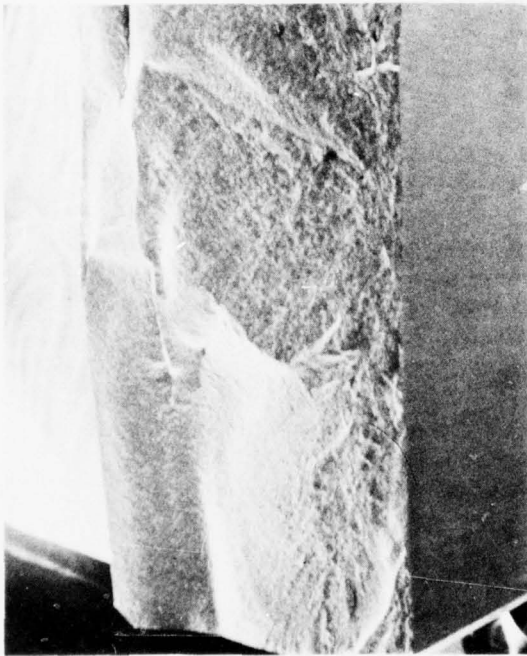
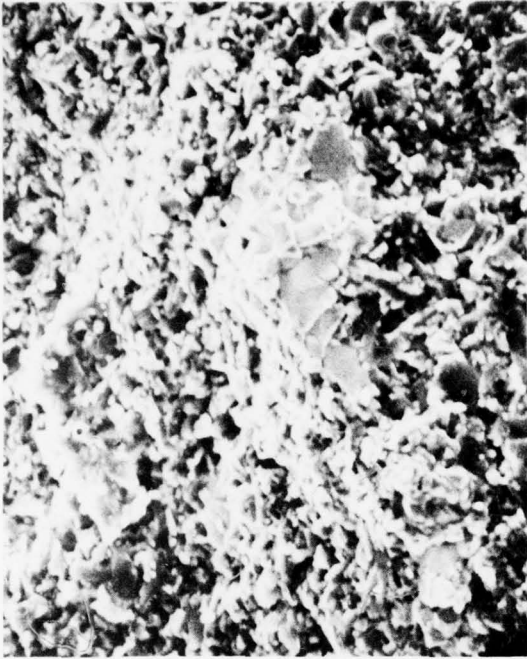
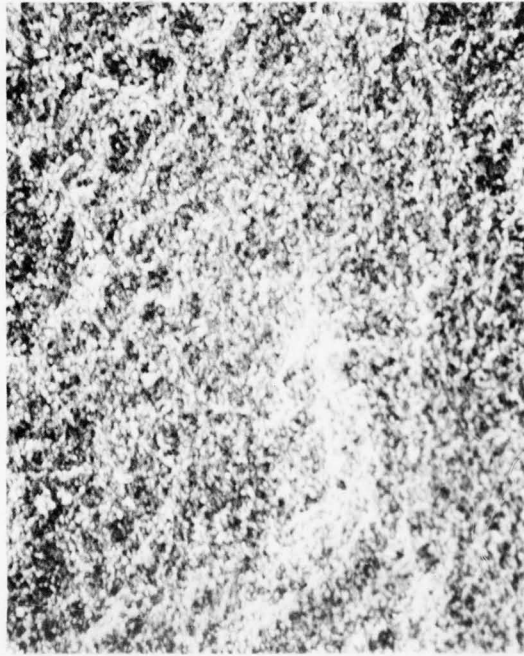
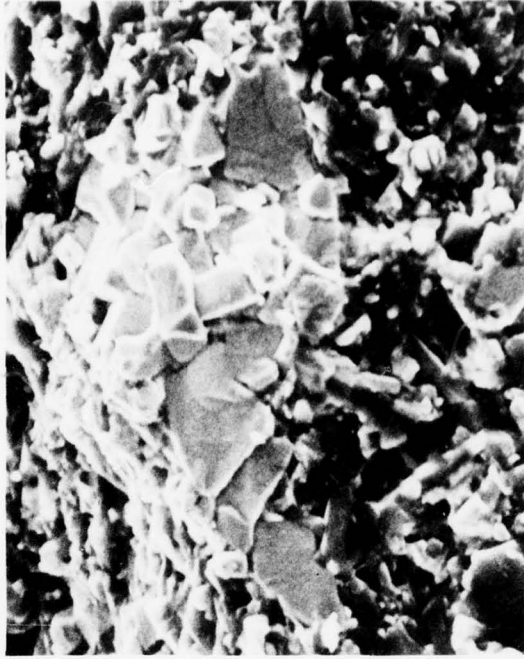
Figure 33. Fracture Surface of Ceralloy 147A Specimen
10 Showing Fracture Initiation Site.

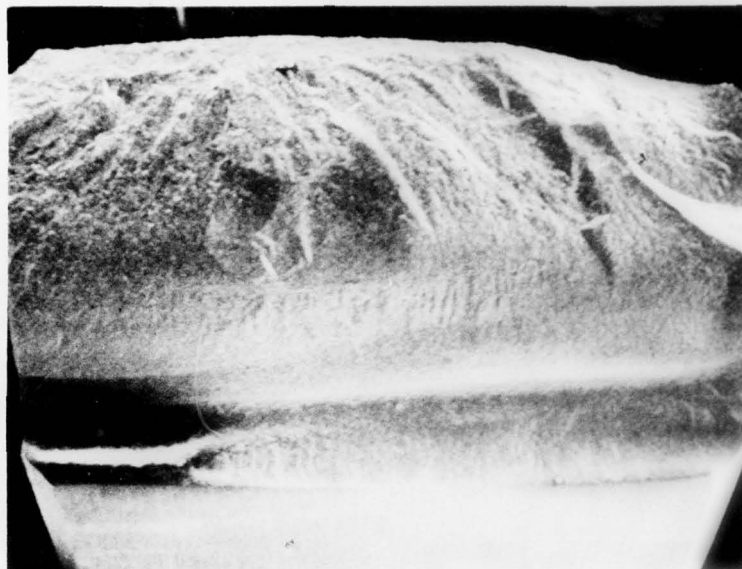
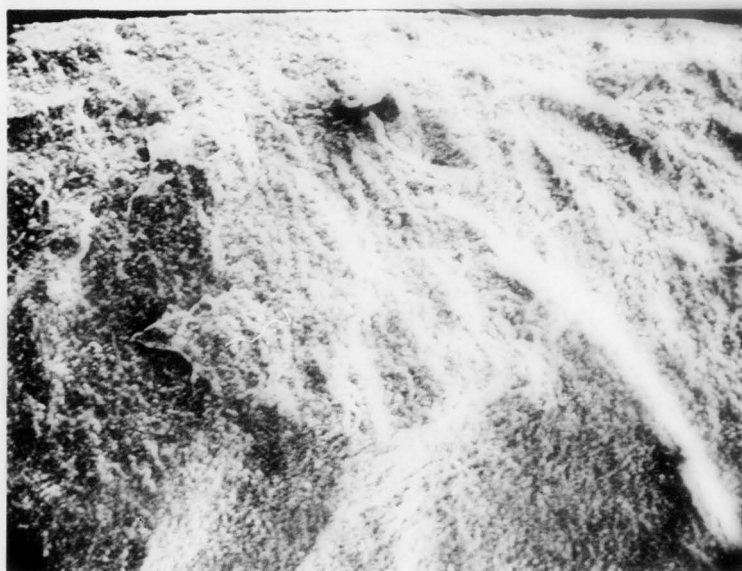
Figure 34. Fracture Surface of Ceralloy 147A
Specimen 13.

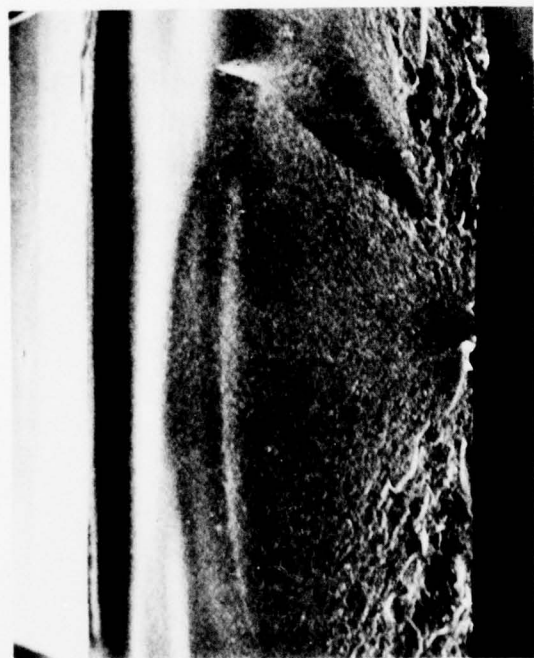
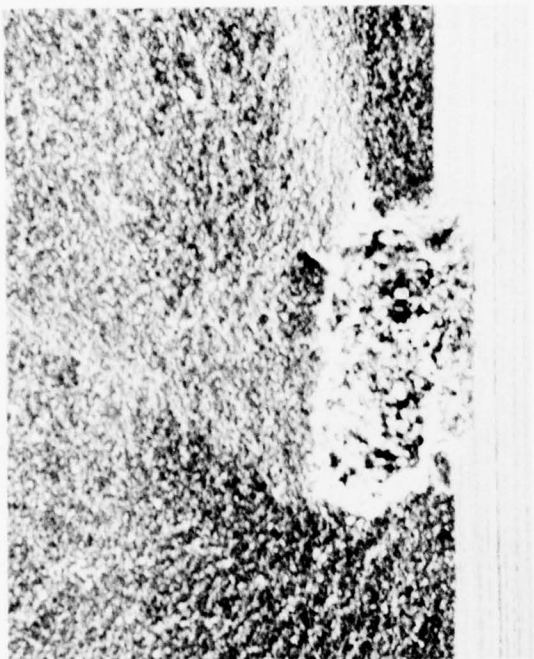
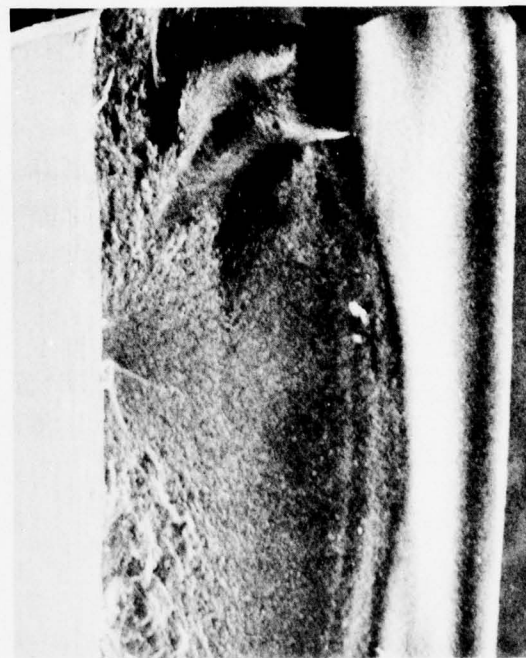
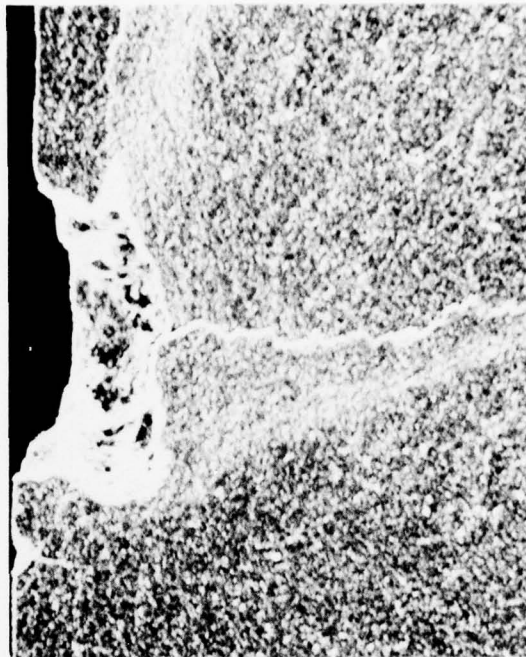
Only specimen 21 of the four specimens of NC-132 tested broke through an ultrasonically detected defect. This defect was a surface pit of hemispherical shape that penetrated about 100 μ m. Since all of the defects in these specimens were in the same plane, the ultrasonic pulse heights should give a good indication of the relative defect sizes. The data in Table IV shows that specimen 21 had by far the largest signal. Therefore, the defects in the other specimens must have been much smaller, or at least shallower, than 100 μ m. The defect in specimen 24 which caused failure was a 30 μ m deep, sharp defect which apparently had a higher stress concentration factor than the surface pit detected ultrasonically. This data indicates that it is important to develop the capability to detect sharp, small surface defects, such as the one in specimen 24, which apparently are too shallow to be detected by the shear wave technique. The results for these specimens are summarized in Table V.

Figure 36. Fracture Surfaces of NC-132 Specimen 21
Showing Fracture Initiation Site.

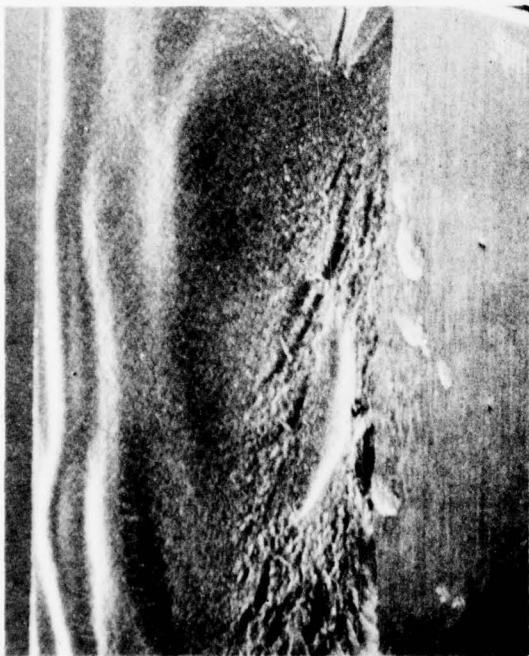
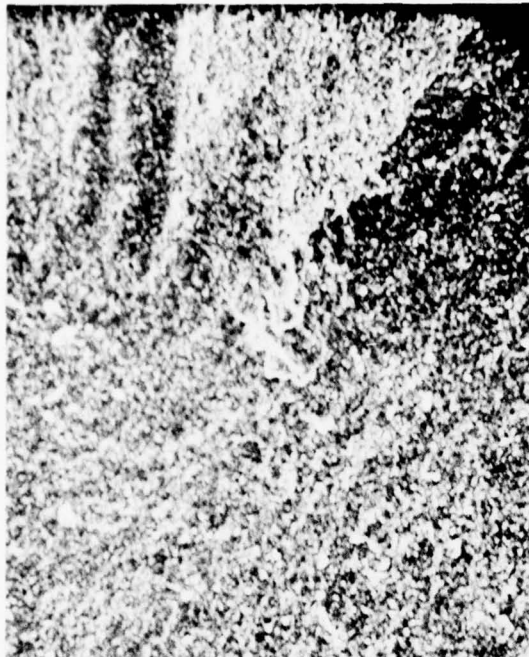
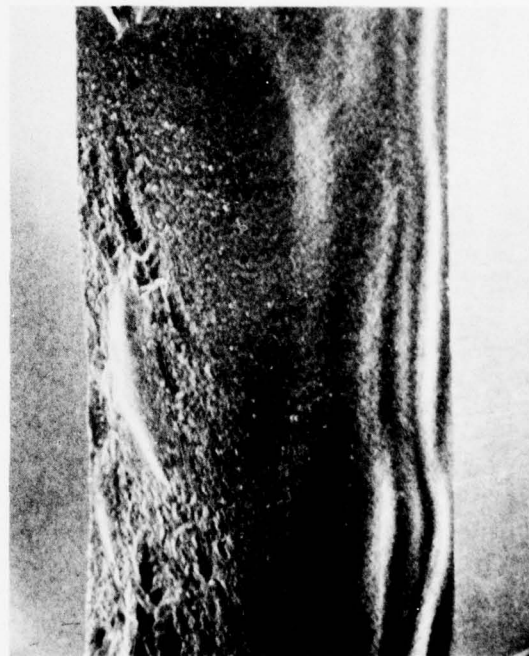
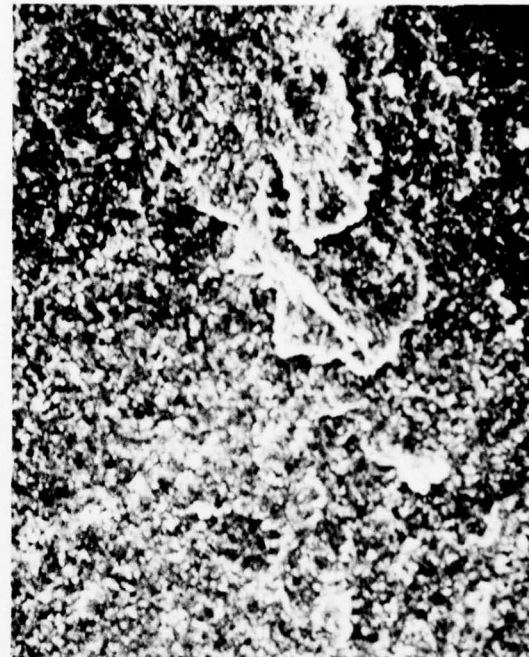
Figure 37. Fracture Surfaces of NC-132 Specimen 22
Showing Typical Fracture Initiation From
Corner.

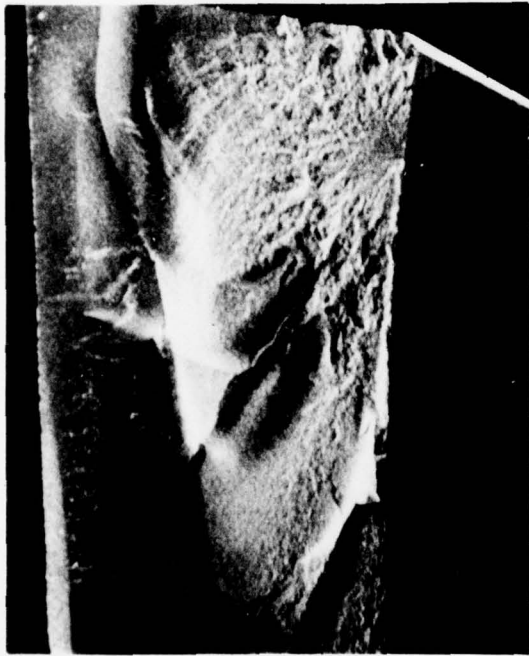
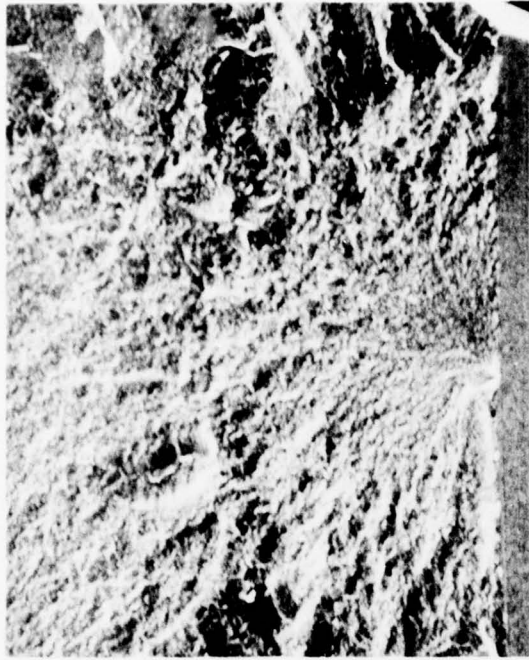
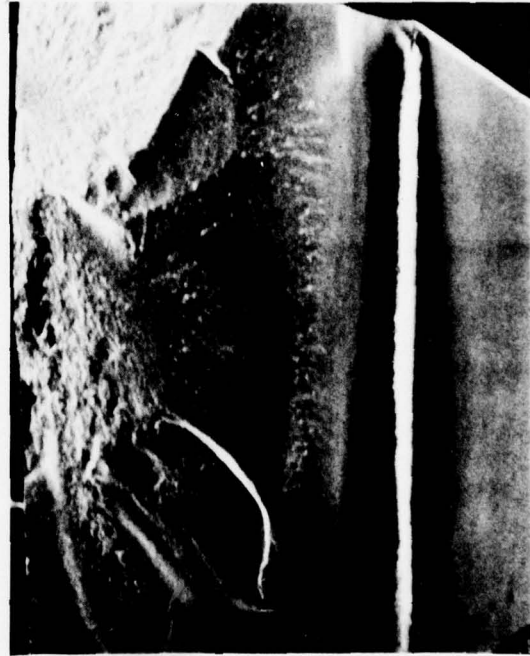
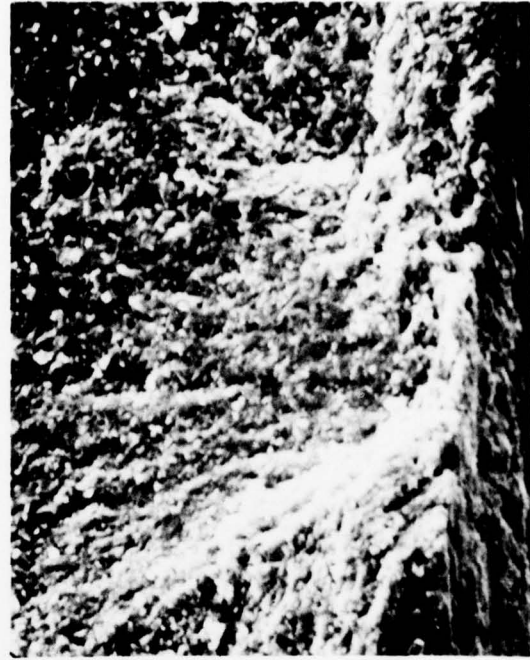
specimen 23 shattered, so that the fracture origin was lost and specimen 24 broke off center. In the case of specimen 24 the surface defect could be observed on one piece of the broken specimen well away from the fracture origin. There were not enough specimens of this material to draw any statistically significant conclusions, however, the general pattern of strengths versus types of failures was similar to the results for Ceralloy 147A.

Figure 38. Fracture Surfaces of NC-132 Specimen 24
Showing Fracture Initiation Site.
